New Elesa HVF in line visual flow indicators

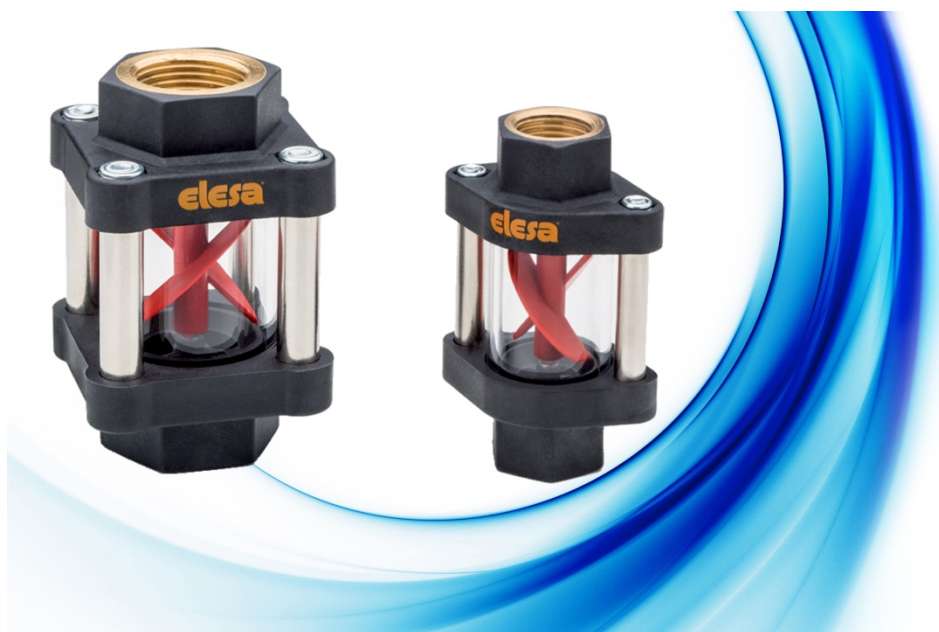
The HVF may be mounted in any position where it offers a 360° view. This simple, cost-effective and maintenance free unit operates with flow in either direction, while its unusual axial impeller design ensures minimal pressure loss in use.

Operation at up to 100°C working temperature and application with a wide range of liquids - including glycol based solutions, is ensured by its rugged construction in Pyrex and polypropylene.
